Wide Bay Building & Pest Inspections

VISUAL TIMBER PEST INSPECTION & REPORT

In accordance with A.S. 4349.3-2010

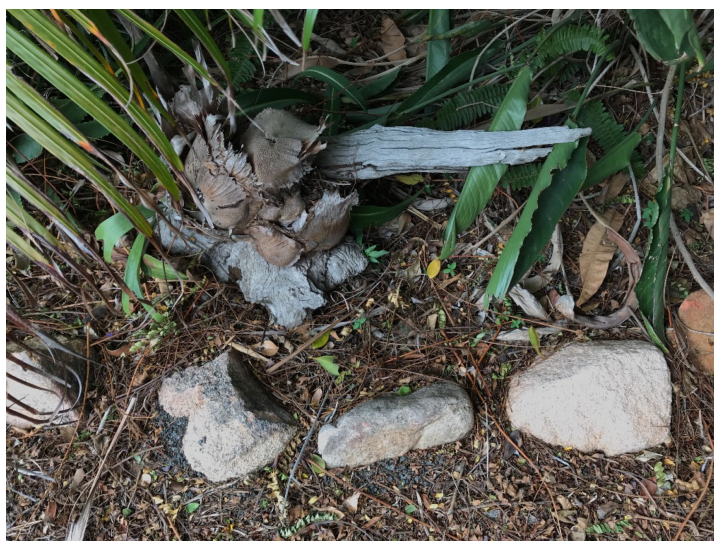
- Stump in the front garden (see photo below).

Shows the stump in the front garden with active termites in it.

Note: Where active Termites are found, we recommend *immediate* treatment and/or further investigation.

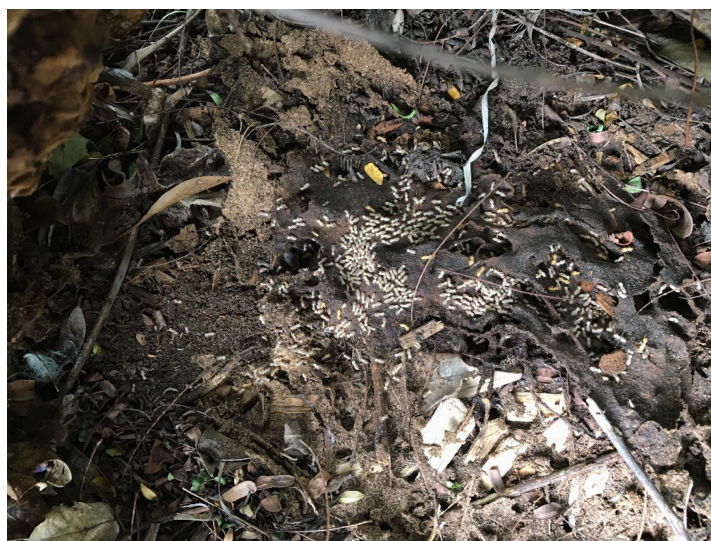
Shows an example of the active termites in/under the stump in the front garden.
