Wide Bay Building & Pest Inspections

Pre-Purchase Inspection - Residential Building Report - (Except ACT)

Complies with Australian Standard AS 4349.1-2007 Inspection of Buildings Part 1: Pre-Purchase inspections - Residential buildings - Appendix "C"

Report Number: WB 1781

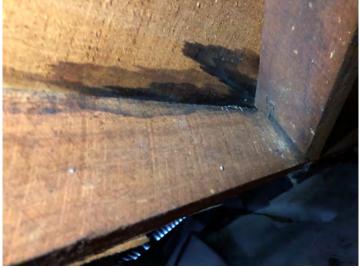
Example of water staining/leaks into roof space below rusted valley gutter.

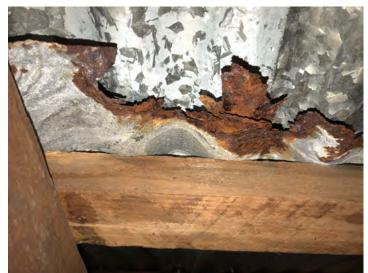
Example of rusted laps/joins to roof sheeting.

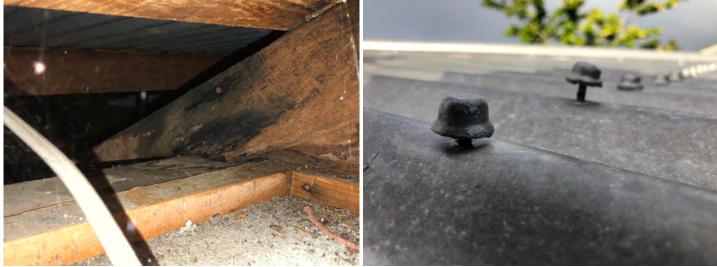
Example of rusted ends of roof sheets.

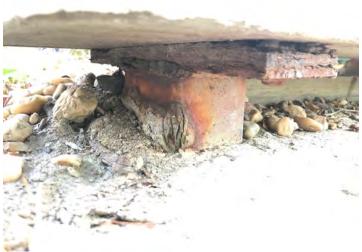
Example of rusted steel posts under stairs.

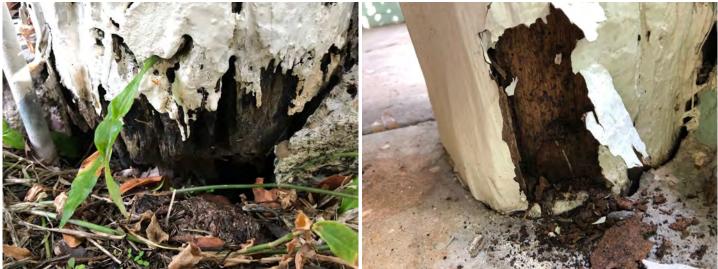
Example of deteriorated/ pencil pointed bases of posts.

Example of House post bases encased in concrete/mortar.

Example of Termite damaged House post.

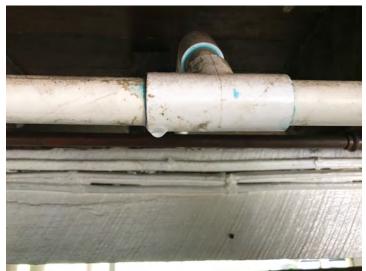
Example of leaking water pipe.

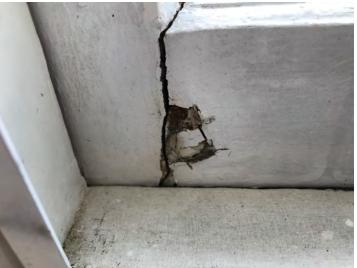
Example of Wood Rot to timber window.
